Intelligent Process Monitoring Is Advancing Gear-making Productivity

By Jorge L. Peña-Mena

A real-time tool monitoring system for gear hobbing machines has been developed and implemented in manufacturing plants to accurately detect and track tool wear through data collection and without changing process parameters.

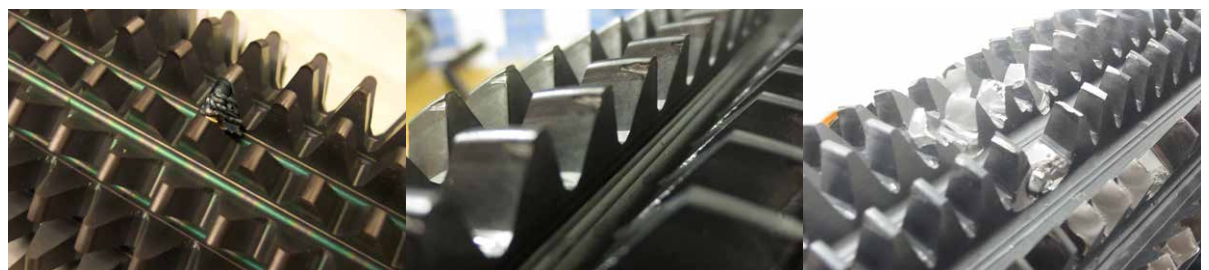
Figure 1: The Artis Tool Monitoring System couples multiple sensor inputs with software specifically designed to detect the exact kinds of anomalies produced by worn and/or damaged tools in wet and dry cylindrical gear hobbing applications

Those parameters are used to create a “signature” for each process and generate a tolerance band around that signature to identify a “good” operation. Monitoring process inputs is not a unique concept, but what makes this application different is coupling those inputs with a software package designed to monitor the signature and simultaneously detect exactly the kind of anomalies produced by worn or damaged tools. (See Figure 1.)

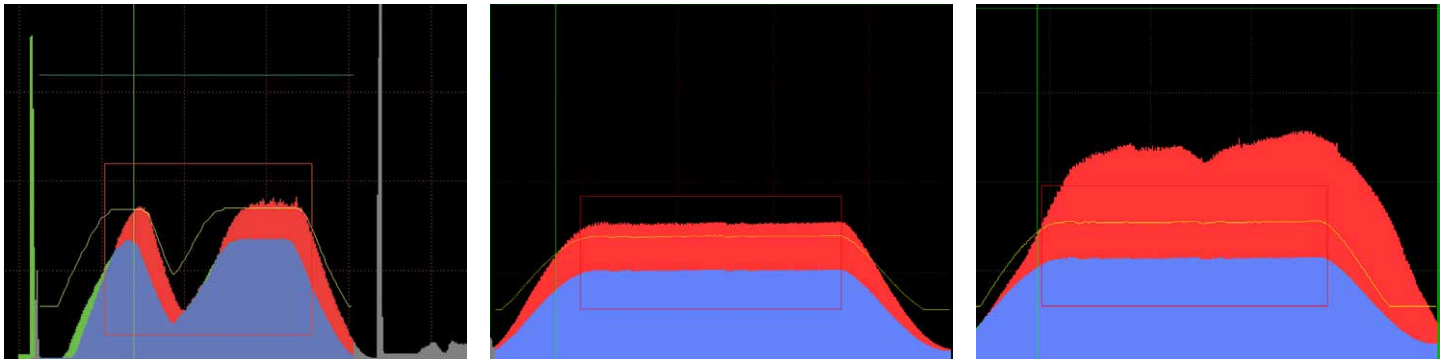
Figure 2: Images from the operator's graphical interface represent a welded chip, coating peeling from the hob, and a broken tooth; all generate a distinct signature that the Artis software can identify and quantify

Fault detection is based on the data gathered during the in-plant monitoring project. It turned out that normal wear, welded chips, peeling coatings, and broken teeth all generate distinct signatures before and during the ultimate failure of the tool. With that information in hand, it is relatively easy to identify and quantify each of these signatures and generate either an approaching end-of-life warning for normal wear or an automatic machine stop in case of actual tool damage. (See Figures 2 and 3.)

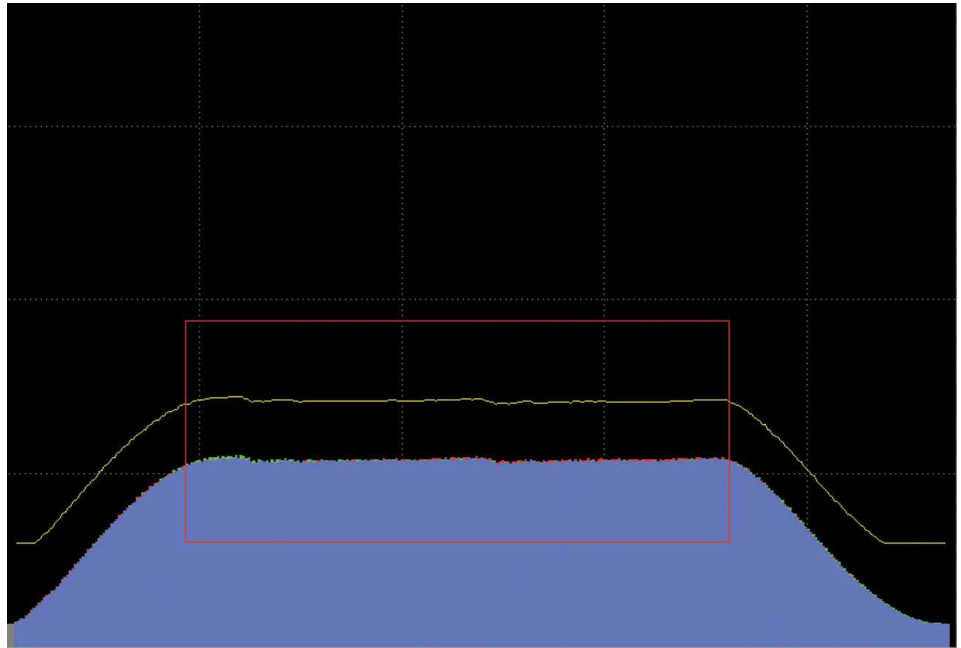
Figure 3: A hob with normal wear

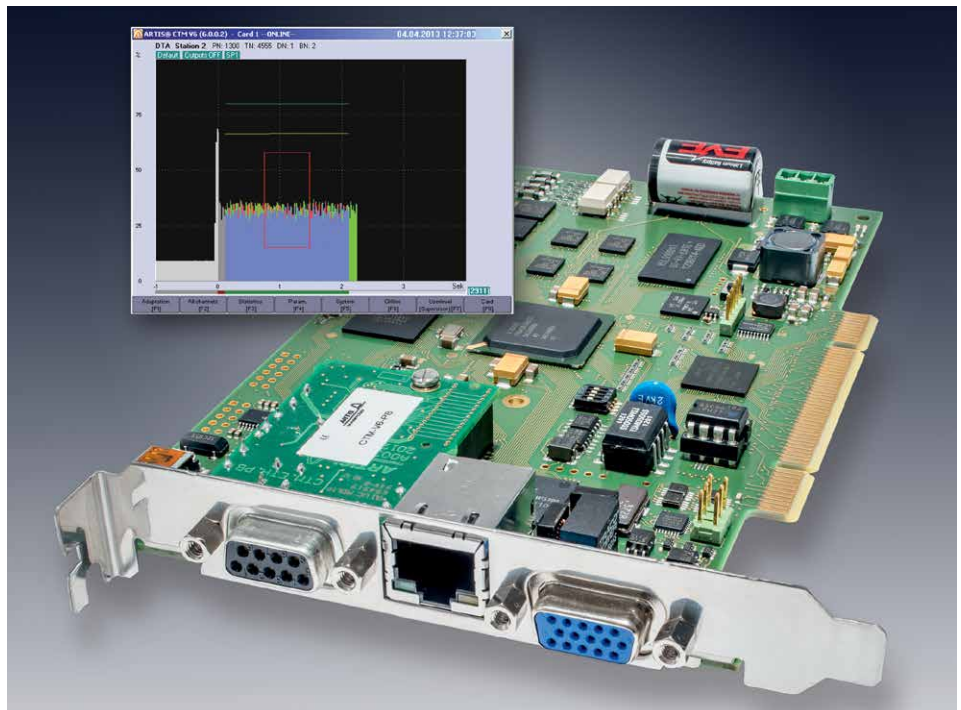
Figure 4: The Artis system can tell gear manufacturers exactly when to change wet or dry cylindrical gear hobbing tools based on what's happening in the cut in real time

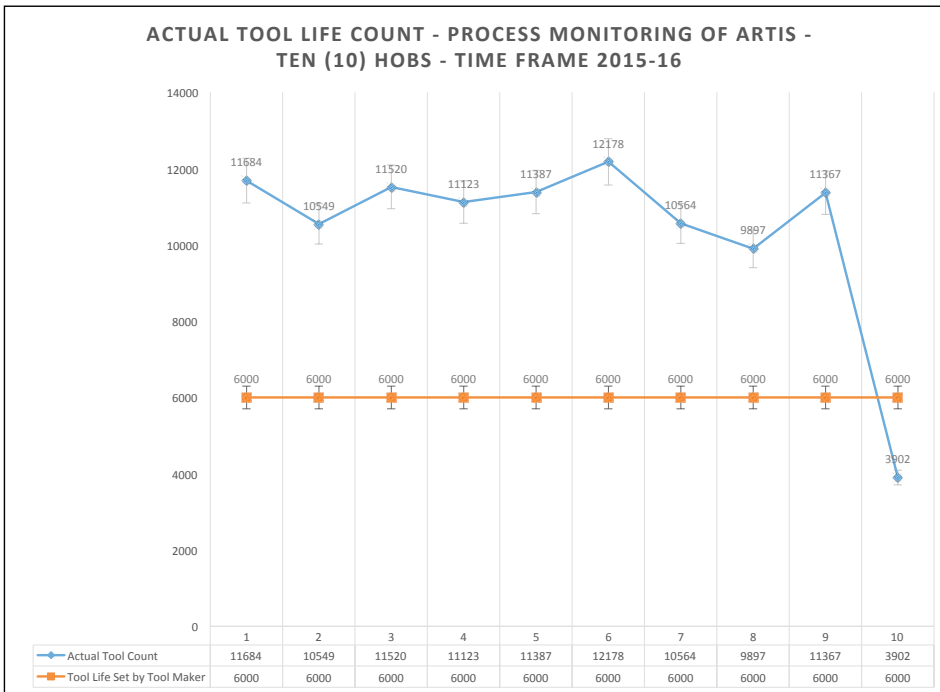
Figure 5: Increase of tool life count by utilizing the Artis process monitoring system

system in place, the same tools are now producing an average of 12,000 hits per re-sharpening with no increase in damage or catastrophic failures. (See Figure 5.)

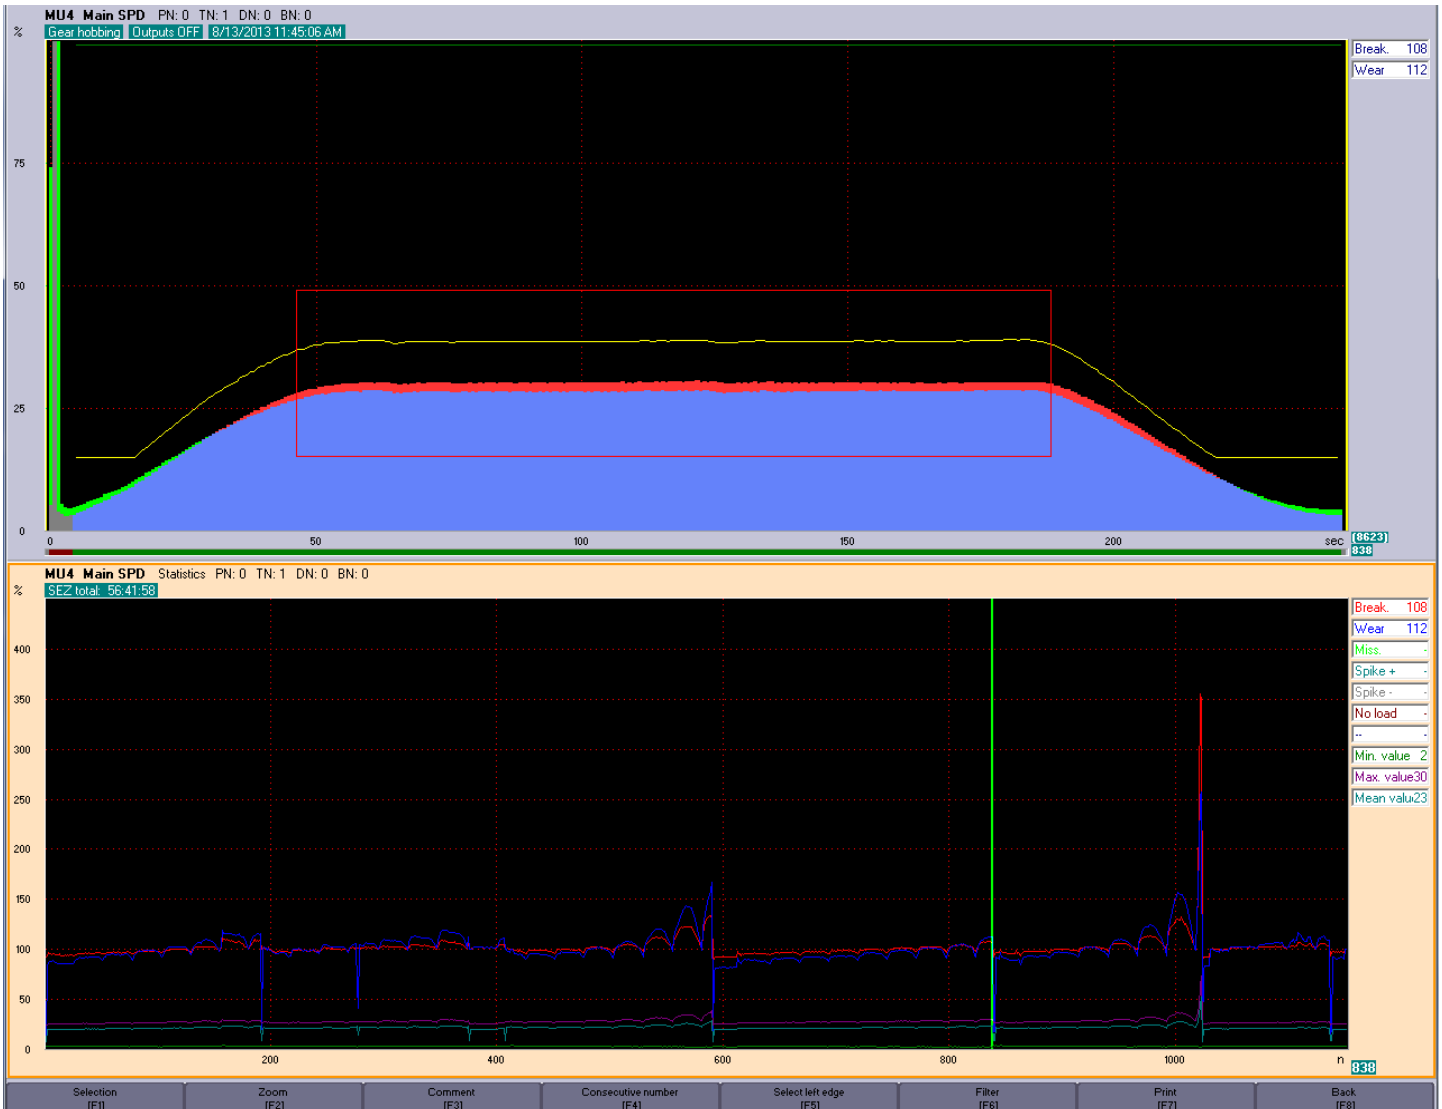
Figure 6: Data generated by the Artis system can be used to visualize and optimize the entire process, not just hob performance
